Identification of the installation/facility :

Country: Germany Location (city): Goettingen Name of the facility: Do 728 cabin test facility Date of construction or of acquisition or of main refurbishment: June 15,2007 Owner: German Aerospace Center (DLR) Contact point: Johannes.Bosbach@dlr.de Internet site: http://scart.dlr.de/site/test-facilities/do728

The Do 728 cabin test facility is a test bed for aircraft cabin research and predicated on the grounded test aircraft 728 Nr. 1 of Fairchild Dornier. It provides a realistic and sound cabin structure, which can be comparatively easily modified or extended, as the modifications do not require permit to fly.

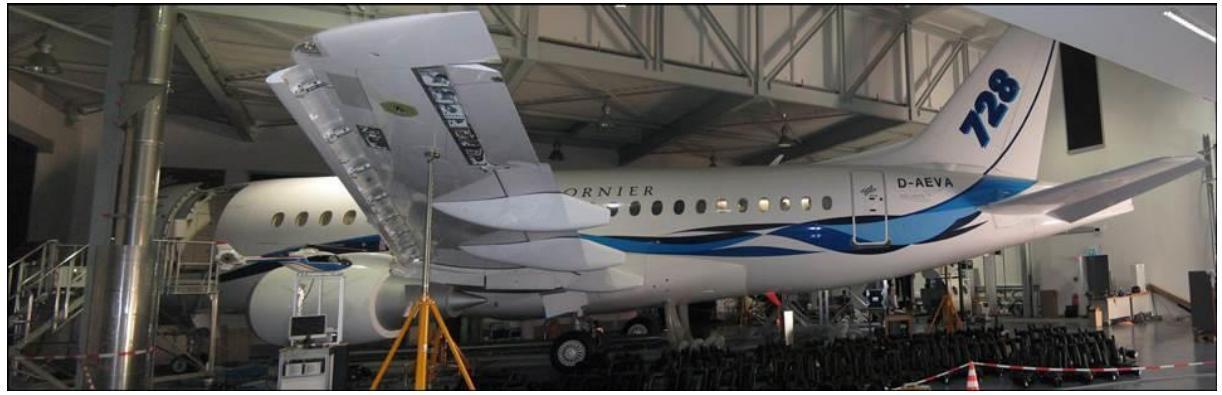
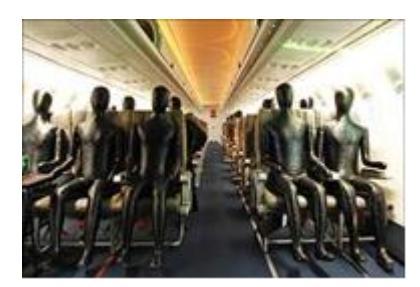
- "single-aisle"
- 16.9m x 3.25m x 2.15 m (L x W x H)
- 14 seat rows with 5 seats each
- Ventilation systems:
 - mixing ventilation,
 - cabin displacement ventilation and
 - ceiling based cabin displacement ventilation
- to be used solely or combined
- External HVAC-System with controlled volume flow rate, temperature and humidity
- Panel audio system for realistic simulation of aircraft cabin noise
- Computer controlled LED system, enabling advanced illumination scenarios
